# Town of Ticonderoga Stormwater Outfall Evaluation Report

Prepared by the Warren County SWCD

For the Town of Ticonderoga and the Lake George Park  
Commission

November 20, 2012

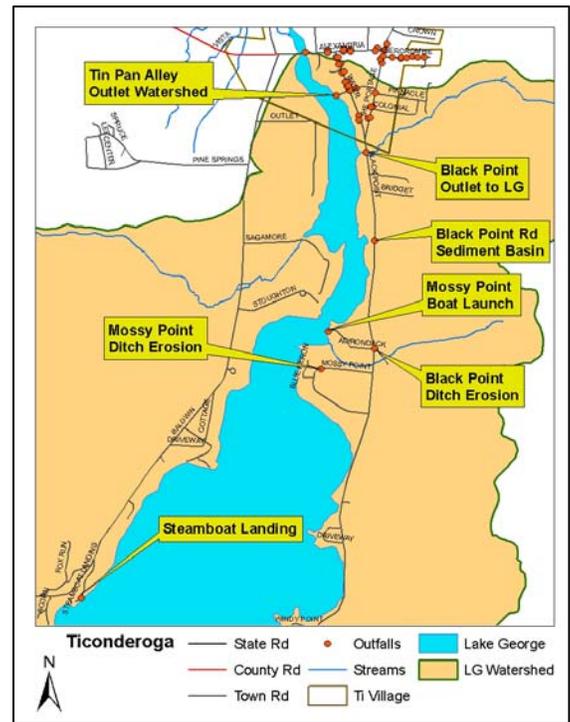
Identified areas of concern

The Tin Pan Alley outlet watershed is the highest priority area in Ticonderoga within the Lake George Watershed (see map below). All of the inlets within the Tin Pan Alley outlet watershed connect and drain directly to Lake George. The outlet watershed is approximately 31 acres in size and drains a significant amount of stormwater to the lake.

The best way to deal with stormwater in a watershed is to break it up by retrofitting sections to prevent runoff into a waterbody through infiltration. The Tin Pan Alley area is difficult due to existing development, steep slopes, clay soils, shallow to bedrock soils and a high water table. These conditions restrict what can be done to remediate this stormwater issue.

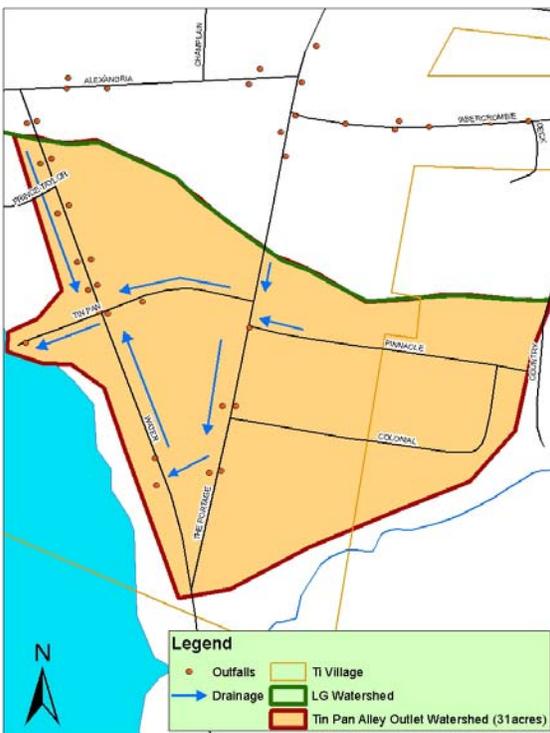
Tin Pan Alley watershed

Since clay soils are identified as Hydrologic Soil Group "D", they have a very slow infiltration rate. While some water holding capacity of soils is wanted, these soils potentially reduce the effectiveness of infiltration as a technique for stormwater treatment. The shallow to bedrock soil situation prevents any structure from going into the ground without a significant cost in blasting. The feasibility of that in this urban area is low as well. Locals with a high water table suffer from the fact that the water floods the infiltration units preventing the solids from dropping out of the stormwater and collecting in the infiltration system. Insects can also be a concern, especially if there is standing water in a unit.

The outlet of this system is less than 100' from the lake and is bordered by the alley which is still considered a car top boat launch site. The area that treatment could occur is very small which makes a typical end of pipe sediment basin unfeasible. If a basin was placed in this location, it would need maintenance after each storm event or it would simply fail with the stormwater runoff and flush out sediments to the lake. The best recommendation for addressing the outfall of Tin Pan Alley is to hire a professional engineer or architect to investigate the design of a high volume stormwater treatment system. The engineer will have to develop a system that can handle storm events from this approximate 31 acre drainage, while keeping in consideration the depth to groundwater for subsurface structures, as they can become buoyant if not installed properly.

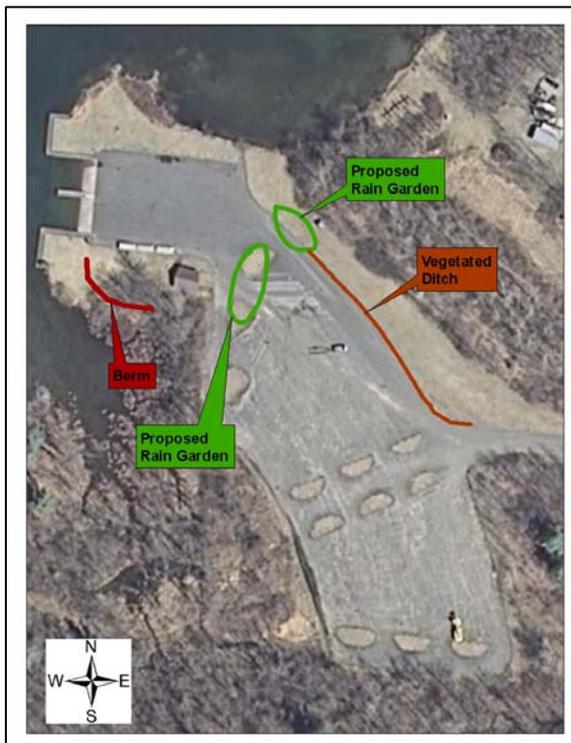
The Mossy Point State Boat Launch is located off of Black Point Road. The boat launch is a large paved lot that leads directly to the lake. Approximately 1/3 of the paved or compacted area flows off of the east side of the parking lot and down the boat launch into the lake carrying sediments, road salt and other pollutants with it. There are twelve small grassed sections of the paved lot that assist in slowing down stormwater velocity and runoff. The remainder of the compacted or paved area sheet flows off to the west and infiltrates into a forested buffer.

The boat launch offers multiple opportunities for stormwater retrofitting to prevent large amounts of runoff from entering the lake. Rain gardens or a larger bioretention basin located at the top of the boat launch or to the east just outside the parking lot would allow stormwater to infiltrate before running down the boat

launch. A vegetated ditch on the east side of the parking lot would assist in directing stormwater into the rain garden. A small outlet located in the northwest section of the parking lot drains directly to the lake. Placing a berm in this location will allow the water to pond and infiltrate prior to reaching Lake George.

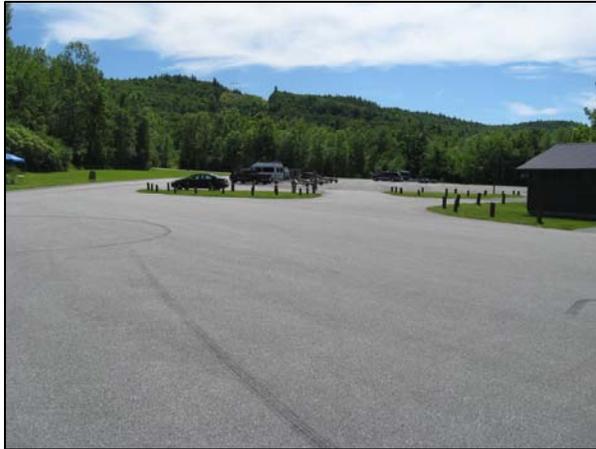
Mossy Point Boat Launch looking from lake

Future recommendations for paving would be the use of porous pavement to allow for immediate stormwater infiltration or paving in a way to direct the stormwater runoff into the vegetated areas around the boat launch. Directing the path of stormwater can be achieved by crowning the road away from the lake and building outlets along the paved edges to allow for runoff into vegetated buffers or future rain gardens.

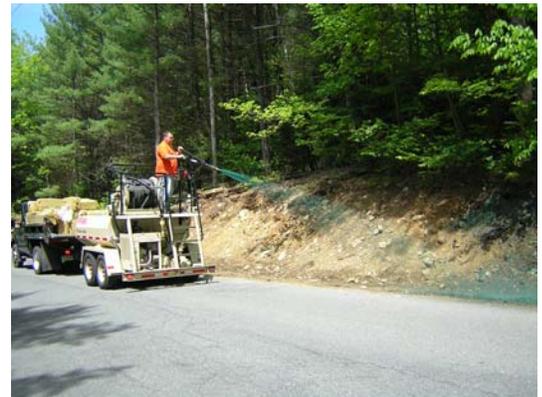
Black Point Road has roadside erosion on the east side across from the Mossy Point boat launch. It does not appear that there are high velocity flows in this section of ditch, so a stone lined ditch may not be necessary. Hydroseeding the eroded ditch this spring will allow vegetation to establish, preventing stormwater from washing away the soils and will help stabilize the banks.

Hydroseeding bare ditch slope

The DEC recognizes that successfully developing a vegetative cover will reduce sediment inputs by up to 90%. A general seed mix that works successfully in the Lake George basin is comprised of creeping red fescue, Kentucky bluegrass, chewing's fescue and perennial ryegrass. It is also advisable to add annual ryegrass, which will germinate quickly for short term vegetative cover, but will not come back the following year.

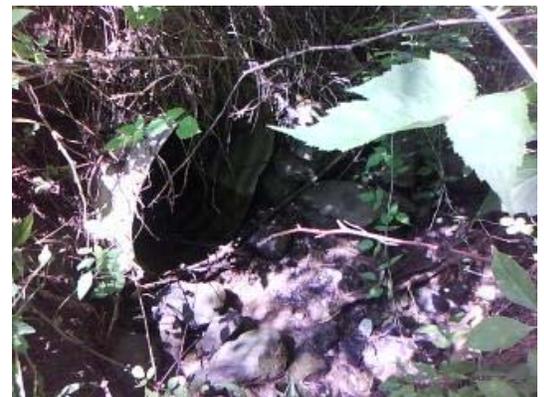
The sediment basin on the east side of Black Point Road just north of the Mossy Point boat launch was installed several years ago and needs to have routine maintenance conducted. In most cases with sediment basins, when their storage capacity has reached 50%, they should be cleaned out. If they are not maintained, then material that has settled out will be transported downstream following rainfall events.

Sediment migrating from basin to outlet

The basin on the west side of the road does not have the same volume of material as that on the east side. It may be that the majority of mobile sediment flows off into the eastern ditch. If that is the case, the eastern basin should be a higher priority for maintenance.

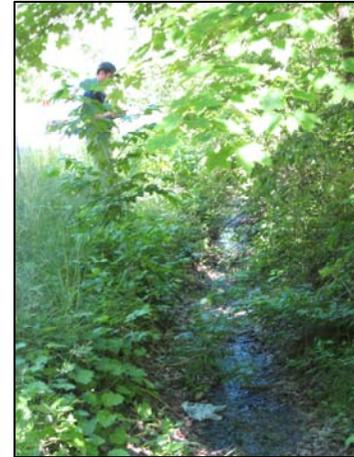
Though relatively stable and vegetated a small area of ditch on this road has degraded and appears to be contributing sediment (see location map). This situation is easily fixable and require only the placement of stone fill to stabilize the eroded area. This stone should be angular between 3" and 6" and should be lightly tapped or set to prevent any mobilization.

Eroded ditch section on Mossy Point Road

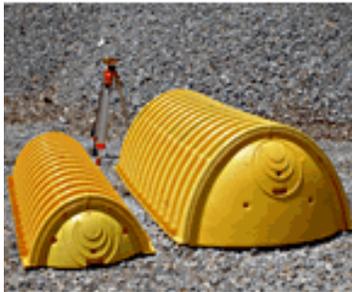
Baldwin Road is an area of stormwater concern. A series of four drywells or a drywell and infiltration chambers should be installed to collect and treat stormwater. The stormwater flowing south down Steamboat Landing drains into Lake George near the Pump Station. The runoff from storms contributes salts, sediments and other pollutants to Lake George. The drywells and chambers will collect and allow the stormwater to infiltrate preventing pollutants from draining directly Lake George.

Steamboat Landing may have a break in the drainage meaning the runoff into Lake George would come from approximately 450' of road averaging out to 5,610 gallons of stormwater in a one inch storm and 2,805 gallons in a half inch storm. If there is not a drainage break, Steamboat Landing will be draining approximately 650' of road averaging out to 8,100 gallons of stormwater in a one inch storm and 4,050 gallons in a half inch storm. The stormwater retrofit will be designed to capture the max amount of stormwater allowable within our construction location constraints. The first flush of stormwater is the most important to capture and infiltrate due to the high concentration of pollutants.

The two options for infiltration systems on Steamboat Landing consist of four drywells or a drywell connected to a series of chambers. The site limitations consist of soil types, sewer and waterlines, depth to water table, and allowable work area size. These limitations will determine size of drywells and number of drywells and or chambers used. The options for drywells are, 4'x6' drywells that hold 688 gallons, and 4'x8' drywells that hold 1,287 gallons. If chambers are used, the Stormtech SC-740 Chambers (or similar) that hold 343 gallons per section length will be the most efficient for the location. With the infiltration chambers, each section can be connected to form a line of chambers or a manifold can run the chambers side by side. This allows the chambers to be maneuvered to fit into locations with site constraints.
