# Town of Ticonderoga Stormwater Outfall Evaluation Report

Prepared by the Warren County SWCD

For the Town of Ticonderoga and the Lake George Park  
Commission

November 20, 2012

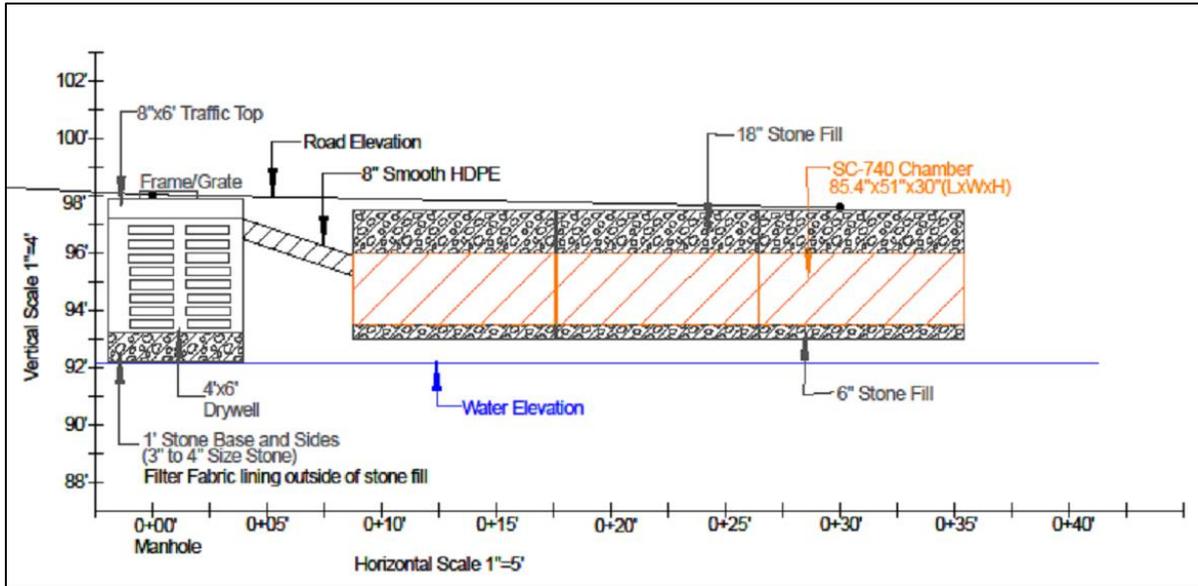
Example of a Drywell and Infiltration Chamber system:

The two options for infiltration systems on Steamboat Landing consist of four drywells or a drywell connected to a series of chambers. The site limitations consist of soil types, sewer and waterlines, depth to water table, and allowable work area size. These limitations will determine size of drywells and number of drywells and or chambers used. The options for drywells are, 4'x6' drywells that hold 688 gallons, and 4'x8' drywells that hold 1,287 gallons. If chambers are used, the Stormtech SC-740 Chambers (or similar) that hold 343 gallons per section length will be the most efficient for the location. With the infiltration chambers, each section can be connected to form a line of chambers or a manifold can run the chambers side by side. This allows the chambers to be maneuvered to fit into locations with site constraints.

Baldwin Road is an area of stormwater concern. A series of four drywells or a drywell and infiltration chambers should be installed to collect and treat stormwater. The stormwater flowing south down Steamboat Landing drains into Lake George near the Pump Station. The runoff from storms contributes salts, sediments and other pollutants to Lake George. The drywells and chambers will collect and allow the stormwater to infiltrate preventing pollutants from draining directly Lake George.
